18 RUTLAND SQUARE BOSTON, MA, 02118

PERMIT SET

A-203

We were asked by Holland Construction to do an assessment of the front windows at 18 Rutland Square.

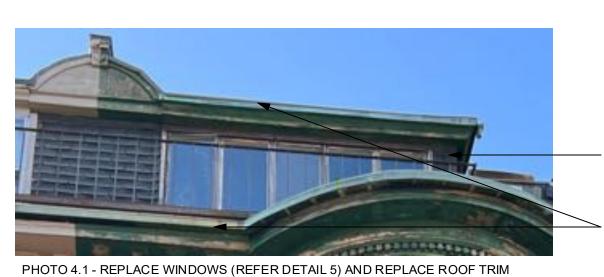
DORMER AT ROOF TO BE RETAINED. EXTERIOR MATERIAL TO BE REPLACED BY SLATE

FLASHING TO BE REPLACED WITH NEW COPPER FLASHING

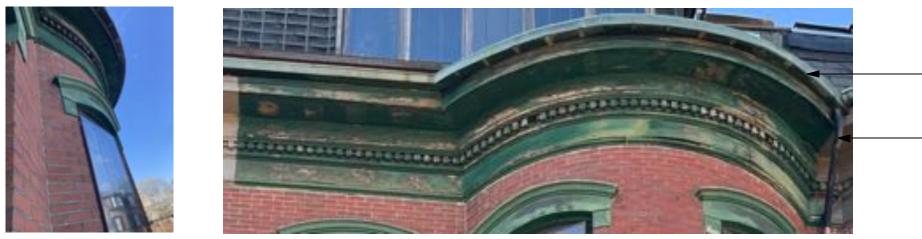
PHOTO 3.2 - RETAIN, REPAIR BROKEN PIECES AND REPAINT EXTERIOR TRIM

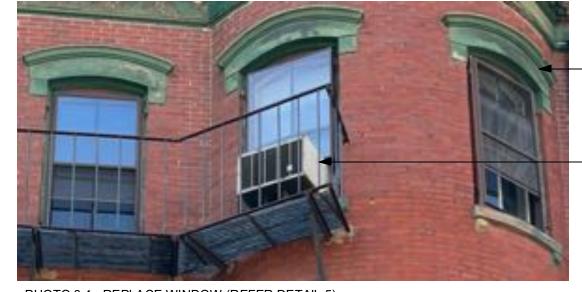
PHOTO 3.1 - REPLACE WINDOW (REFER DETAIL 5) RETAIN/ REPAIR LINTEL AND SILL, PAINT FINISHED (SEE NOTES)

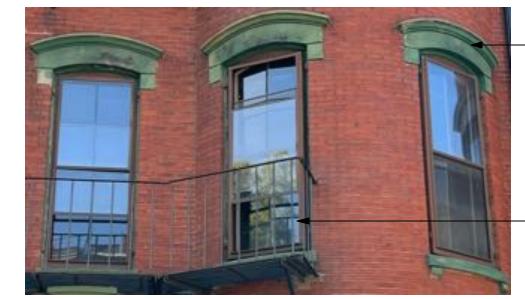
PHOTO 2.1 - REPLACE WINDOW (REFER DETAIL 5) RETAIN/ REPAIR LINTEL AND SILL, PAINT FINISHED (SEE NOTES)

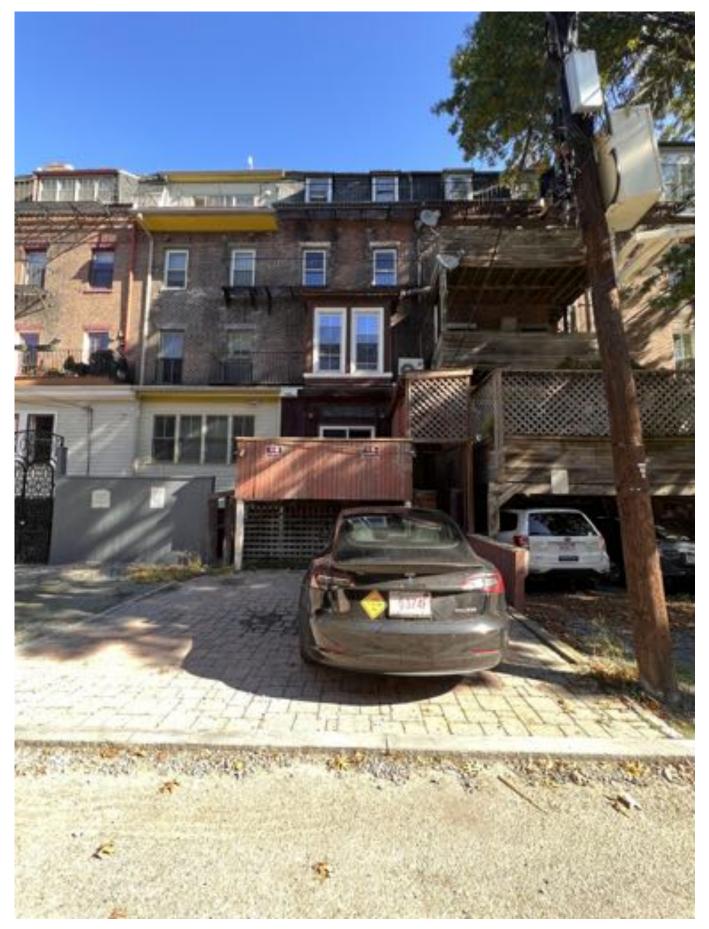
REAR OF THE BUILDING

REPLACE DAMAGED ROOF BY ZINC ROOFING

REPLACE CORRODED DOWN SPOUT BY NEW
