Constructed in 1899-1900 on a vacant lot by architect Alfred J. Manning with designer Louis Comfort Tiffany for Frederick Ayer and his wife Ellen Barrows (Banning) Ayer. They Ayers lived in the mansion until their deaths in 1918.

Existing Conditions – Commonwealth Facade

395 COMMONWEALTH AVE

Existing Plans - Protected Spaces

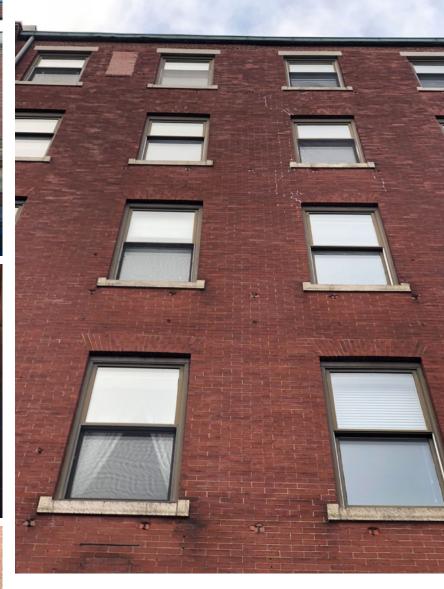
Existing Conditions – Marlborough Street Facade

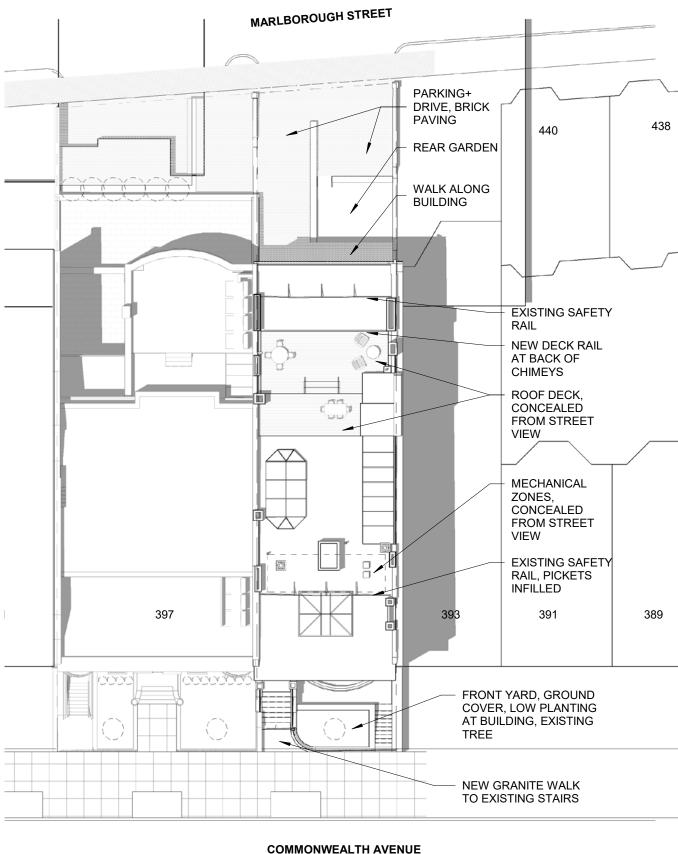
Site + Roof Plan as Approved by the BBAC

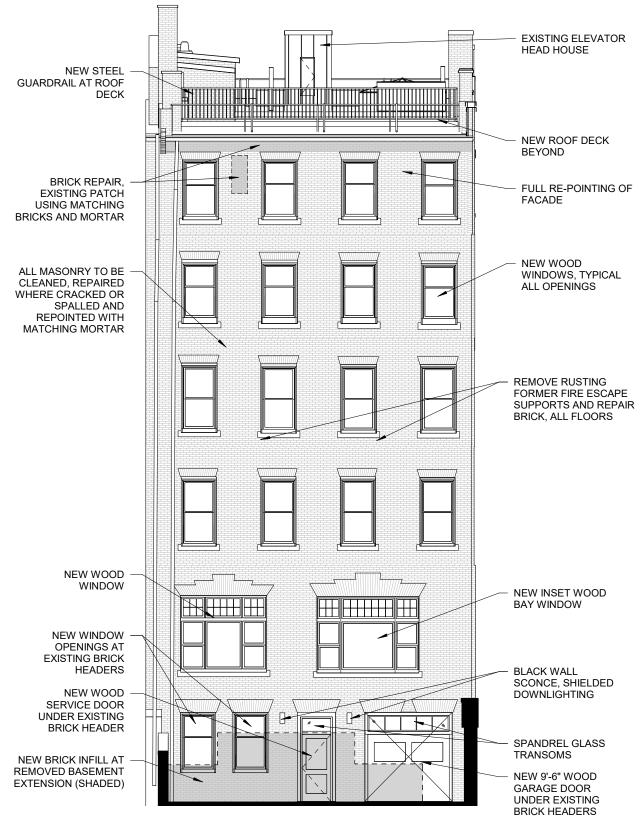
Marlborough Elevation as Approved by the BBAC

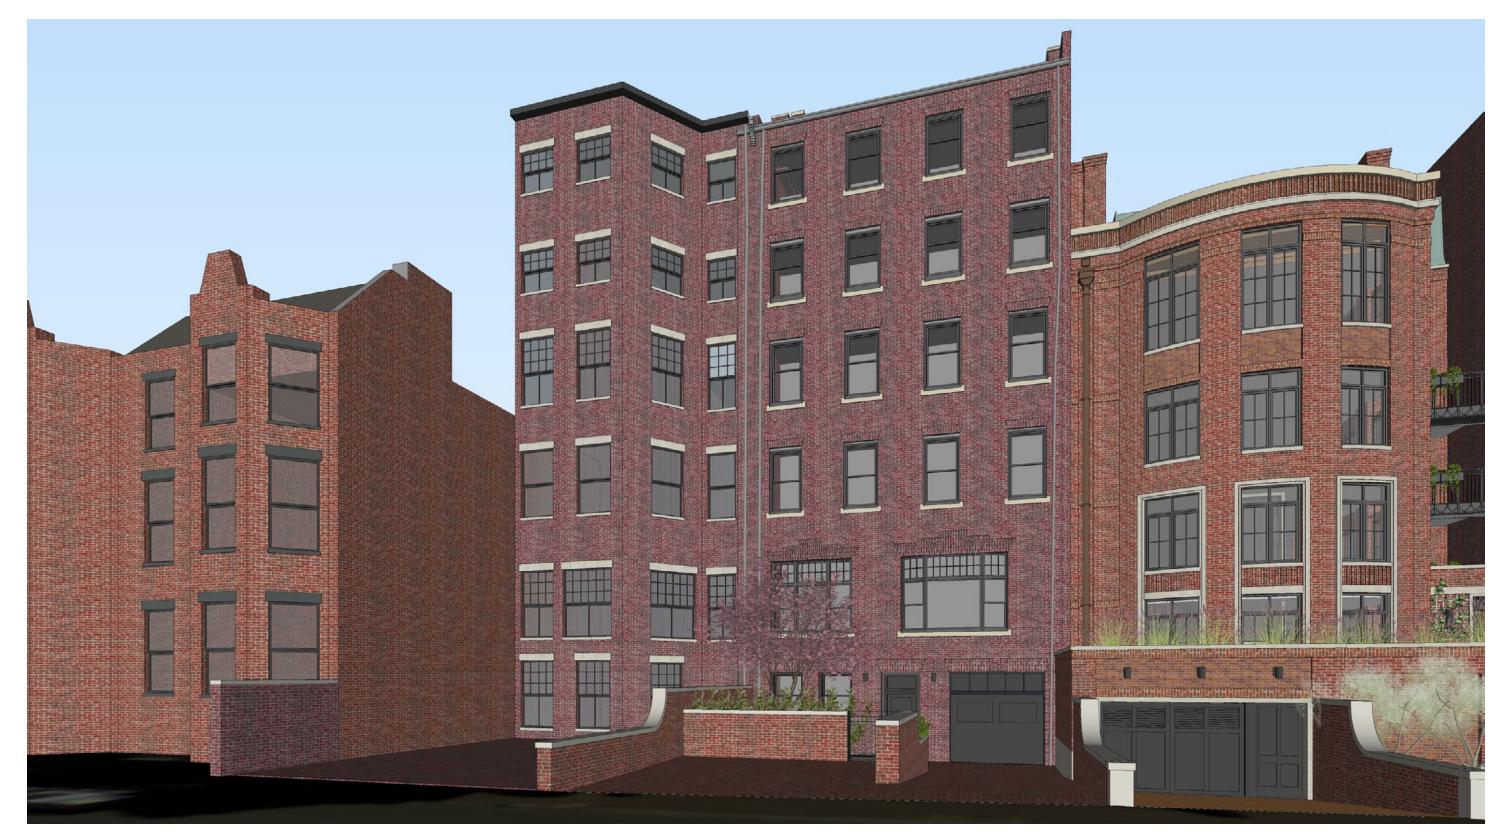
Marlborough Views as Approved by the BBAC

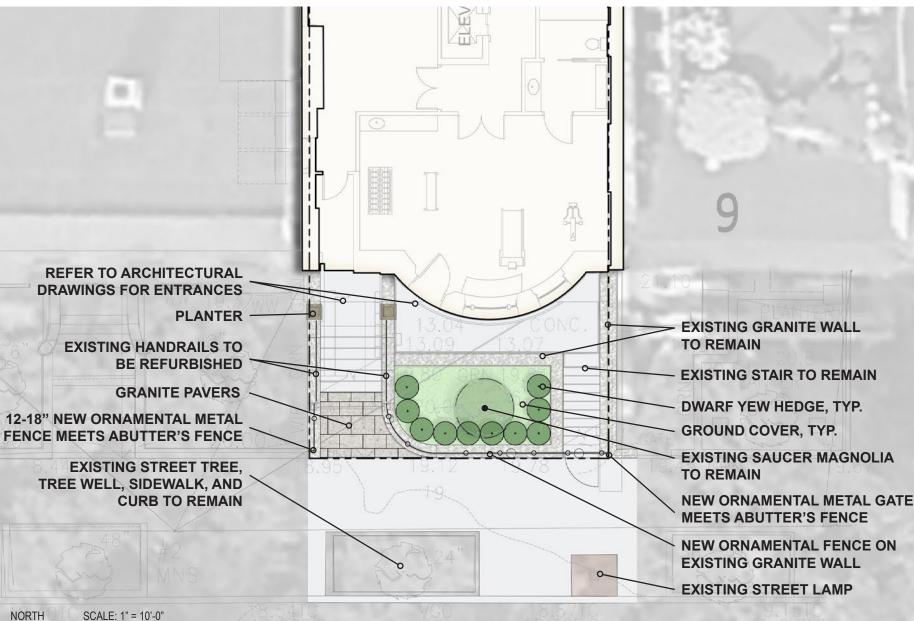
Keep Existing Handrails at Main Entrance

Replace Existing Fence with Low

Remove Existing Gate at Main

12-18" Ornamental Metal Fence on Existing Granite Wall

Evergreen Groundcover (Vinca Minor)

Existing Saucer Magnolia to Remain

Landscape Design - Commonwealth Frontage (as Approved by the BBAC)

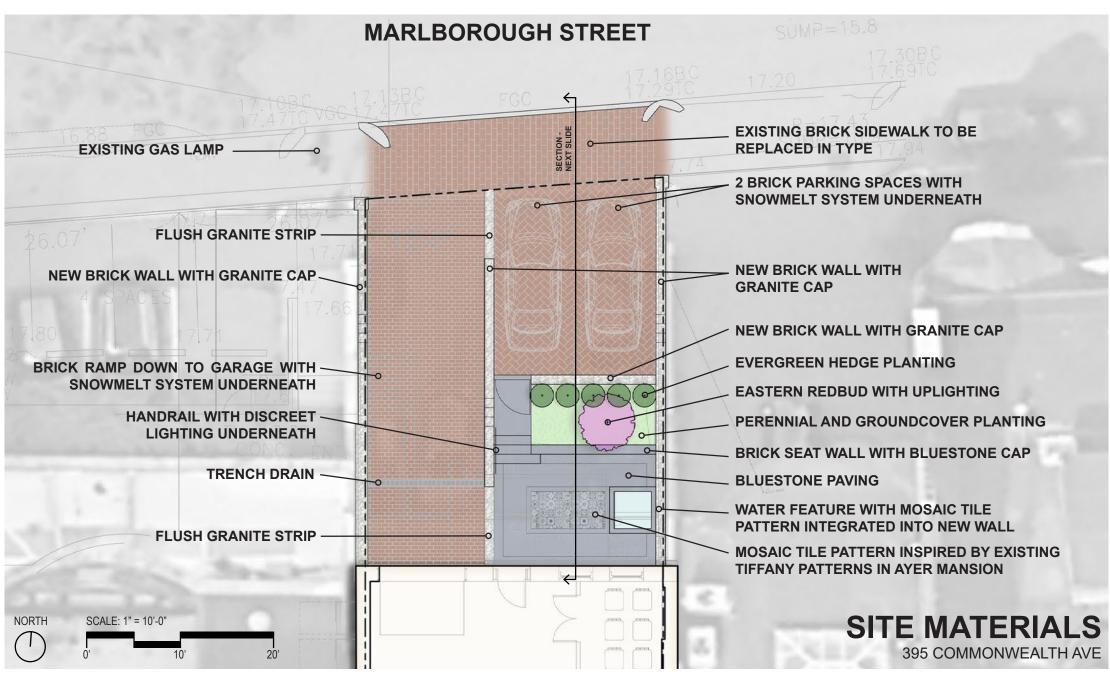
Running Bond Brick Pattern at Garage Entrance

Parking Brick Herringbone Pattern (Brick)

Water Feature Integrated Into Wall

Landscape Design - Marlborough Frontage (as approved by the BBAC)

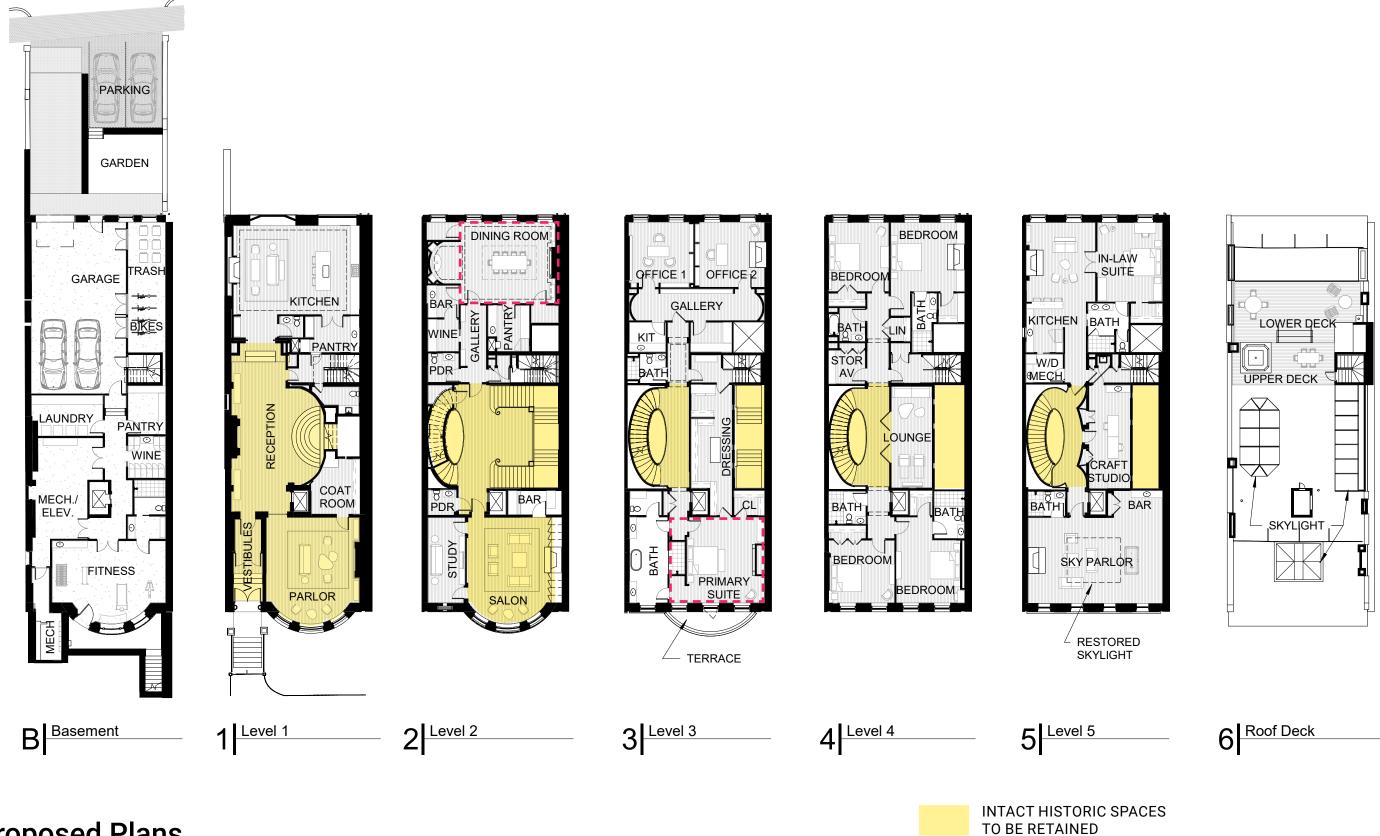
INTACT HISTORIC SPACES

TO BE RETAINED

PREVIOUSLY ALTERED SPACES

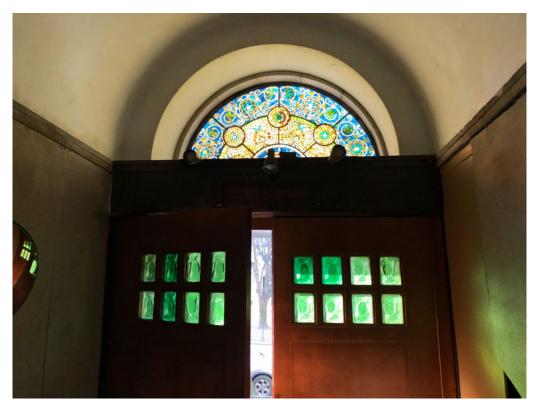
Stained glass transom

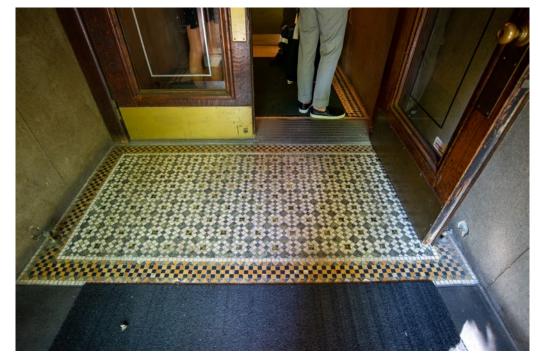
Outer vestibule mosaic, inner vestibule doors

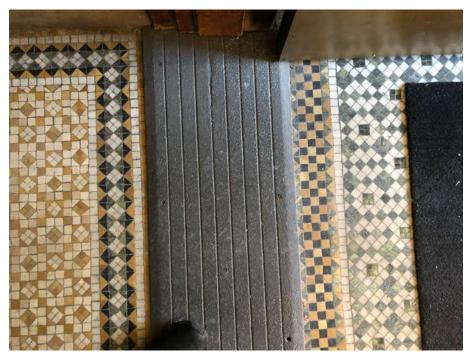
Inner and outer vestibule mosaics

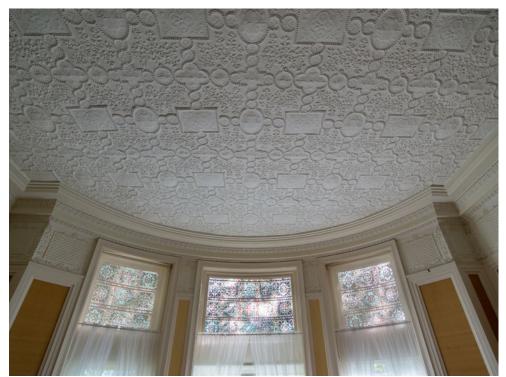
Ceiling, replica stained glass (plastic film)

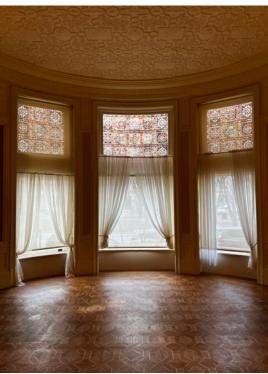
Front bowed windows, curved glass

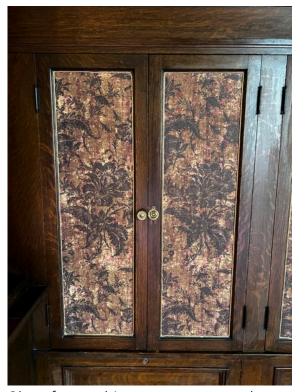
Glass front cabinets, paper covered

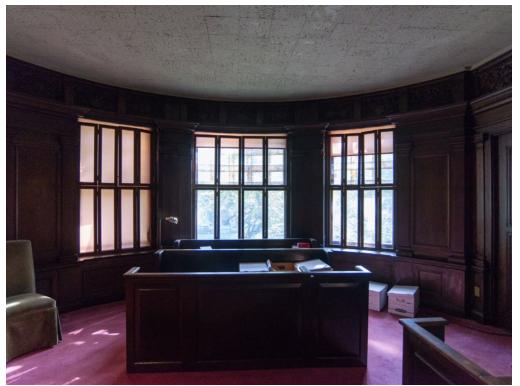
Bow windows, curved glass, original stained glass

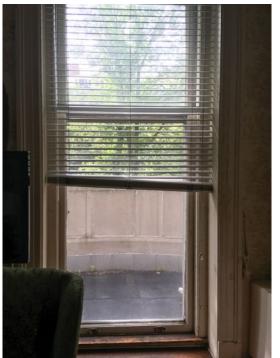
Original tall double hung at balcony
