RESIDENCE AT 389 MARLBOROUGH STREET

BACK BAY ARCHITECTURAL COMMISSION

COVER SHEET

389 MARLBOROUGH STREET

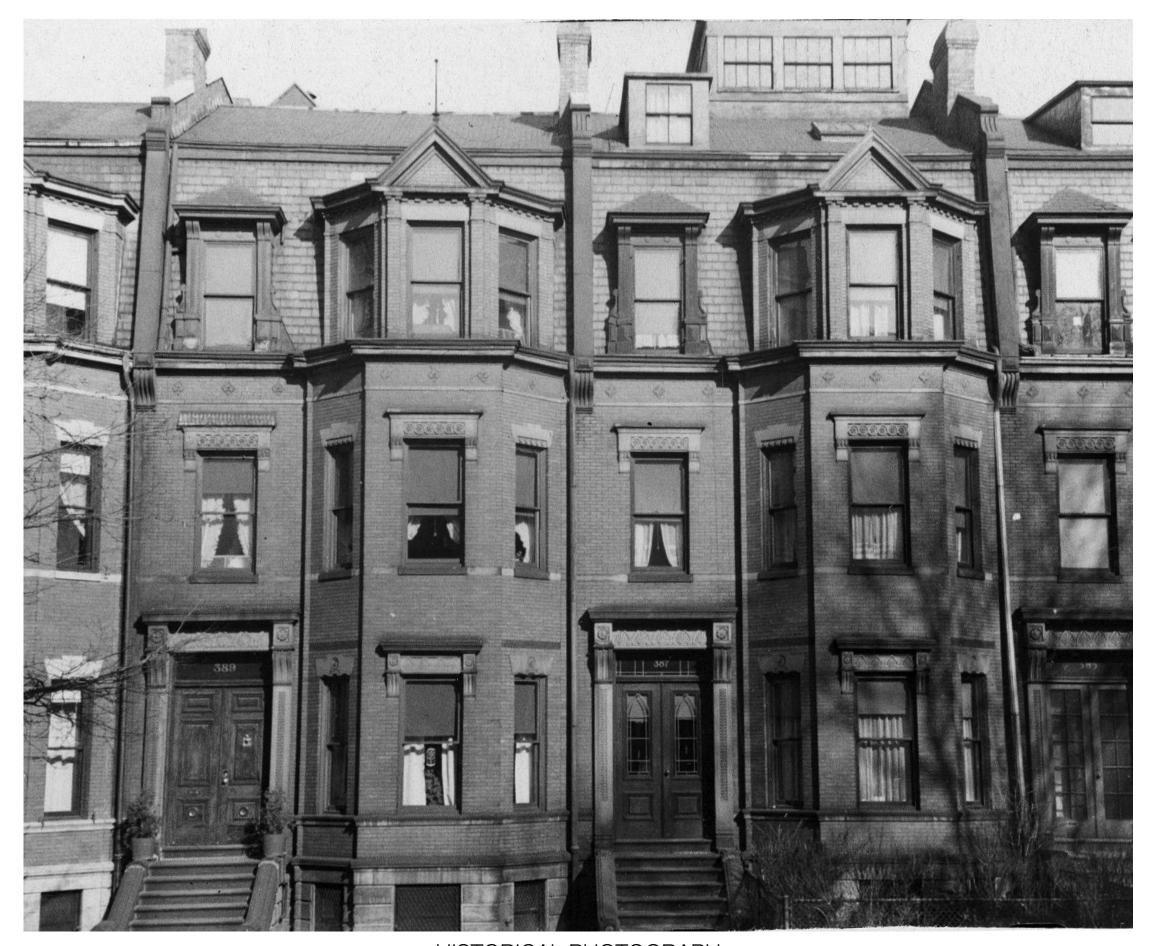
## HISTORICAL PHOTOGRAPH

Black-And-White Photograph circa 1942 by Bainbridge Bunting courtesy of the Gleason Partnership & Back Bay Houses

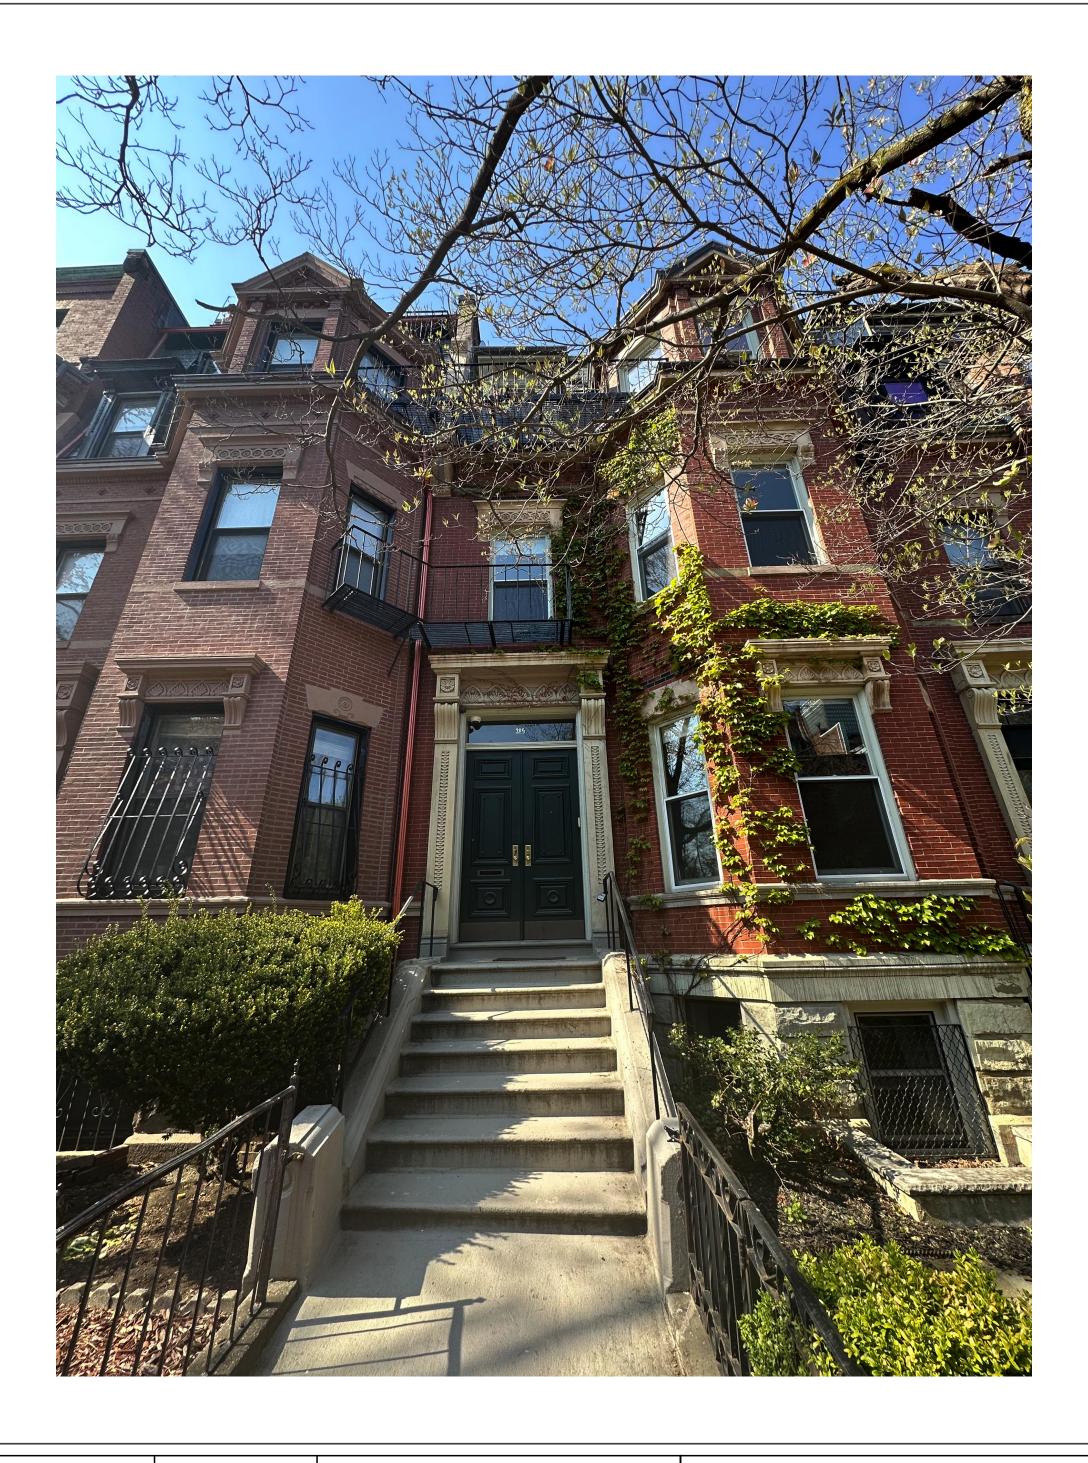
A-2.0

05/ 23 / 23 DATE 5258 BRICK FACADE & DECORATIVE
ORNAMENTATION

EXISTING NOTE: RUST & METAL DETERIORATION AT

EXISTING FIRE ESCAPE; REQUIRED FOR EGRESS FROM 391 MARLBOROUGH STREET (MULTIPLE

NO EXISTING
EXTERIOR LIGHT SOURCE AT FRONT ENTRANCE

(REQ'D BY CODE)

EXISTING NOTE:
DIRT & DEBRIS ON CAST STONE ODOOR SURROUND

EXISTING NOTE:
FADING PAINT FINISH, DETERIORATING
CONDITION & LACK OF WEATHER-SEALING ON
ORIGINAL WOOD ENTRY DOOR & TRANSOM;
UNDISTINGUISHED REPLACEMENT BRASS
HARDWARE

EXISTING NOTE: UNDISTINGUISHED REPLACEMENT IRON HANDRAIL

> EXISTING NOTE: SURFACE DIRT & DEBRIS ON CAST STONE PEDIMENT

EXISTING NOTE:
PERVASIVE VINES OBSCURING
BRICK FACADE & DECORATIVE
ORNAMENTATION

EXISTING NOTE:
1-OVER-1, DOUBLE-HUNG WOOD
WINDOWS, PAINTED WHITE AT 
EXTERIOR SASHES & JAMBS
(TYPICAL ACROSS FACADE)

EXISTING NOTE:
EXTENSIVE DRIP MARKS AT
STONE SILL & WATER TABLE FROM
DETERIORATING GUTTERS ABOVE

EXISTING NOTE: CRUMBLING & PEELING NOVA SCOTIA SANDSTONE AT WATER TABLE

> EXISTING NOTE: CONCRETE WINDOW WELL WITH DIRT & SCALING

- Clean and restore brick facade as required.
- Clean and restore decorative stone ornamentation, pediments, sills, and water table.
- Restore existing wood entry doors and transom, and install new entry door hardware.
- Add exterior hanging lantern, centered over entry door.
- Restore existing (non-original) 1-over-1 double-hung wood windows and paint, black.
- Cut back fire balcony above cornice line at 3rd Floor, to terminate just beyond the line of the mansard dormer and does not interrupt the masonry bay.
- Restore mansard-level wood dormer trim and paint, black.

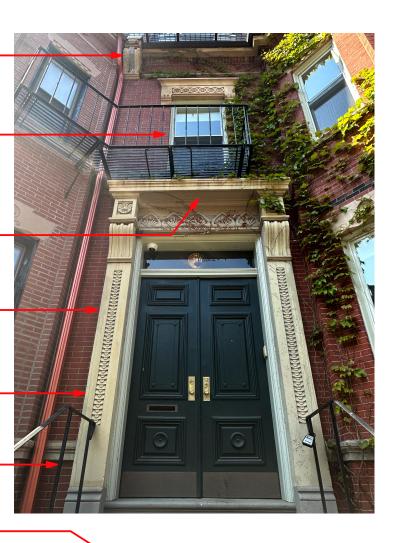
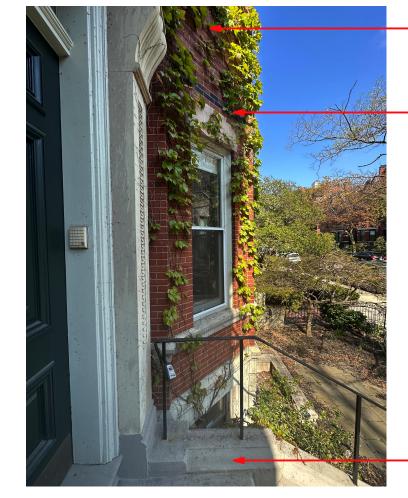
4-2.1

EXISTING NOTE:
DIRT & DEBRIS AT STOOP STEPS
WITH CRACKING & PEELING AT
CEMENTIOUS COATING

EXISTING NOTE:

PERVASIVE VINES OBSCURING

BRICK FACADE & DECORATIVE

FADED 2-COURSE PAINTED BAND

(BLACK) OVER WINDOWS ON

FLANKING SIDES OF BAY

(TYPICAL BOTH SIDES)

EXTENSIVE DRIP MARKS AT

STONE LINTELS FROM

DETERIORATING GUTTERS ABOVE

EXISTING NOTE:
SINGLE-LITE, DOUBLE-HUNG WOOD
WINDOWS, PAINTED WHITE AT
EXTERIOR SASHES & JAMBS
(TYPICAL ACROSS FACADE)

EXISTING NOTE:
MANSARD-LEVEL WOOD DORMER
TRIM PAINTED WHITE & SHOWING
MINOR SIGNS OF DETERIORATION

EXISTING NOTE:
RUST & METAL DETERIORATION AT
EXISTING FIRE ESCAPE, WHICH
CONNECTS ACROSS DORMER TO
WINDOW AT FRONT BAY;
REQUIRED FOR EGRESS FROM
391 MARLBOROUGH STREET
(MULTIPLE UNITS)

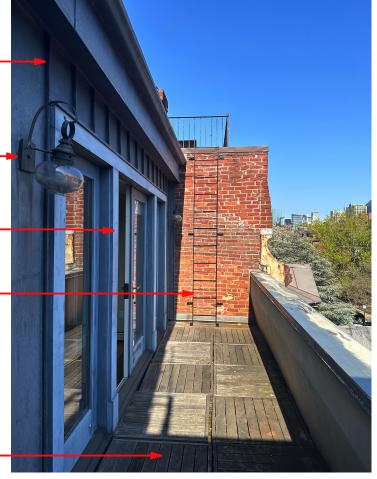
PENTHOUSE TERRACE LOOKING EAST

EXISTING NOTE:
DETERIORATING ONION BULB
LANTERNS ON EACH SIDE
OF PENTHOUSE DOORS
(c. 1998 PER ISD RECORDS)

ROT & DETERIORATION AT
EXISTING WOOD DECKING TILES AT
TERRACE FLOOR

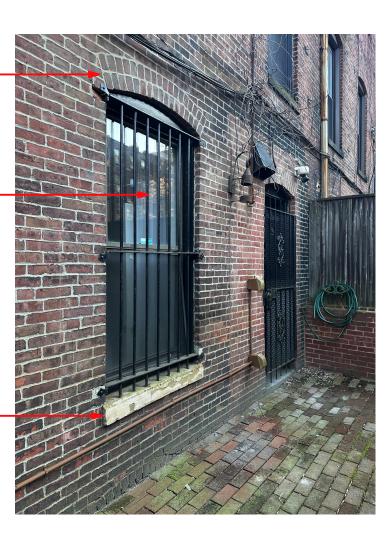
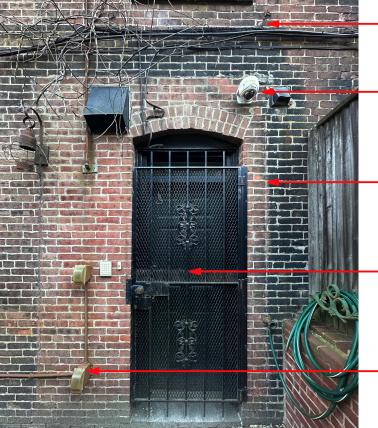
A - 3.2

EXISTING NOTE:
RUST & METAL DETERIORATION AT
EXISTING FIRE ESCAPES,
WHICH EXTEND ACROSS MULTIPLE
WINDOWS AT 2ND, 3RD & 4TH
FLOORS & ARE
REQUIRED FOR EGRESS FROM 391
MARLBOROUGH STREET (MULTIPLE
UNITS)

EXISTING NOTE:
EXTENTS OF FIRE ESCAPES AT 2ND,
3RD & 4TH FLOOR

EXISTING NOTE:
CRACKING ON MASONRY FACADE

EXISTING NOTE: SEGMENTAL ARCH AT DOOR LOWER THAN ARCHES AT ADJACENT WINDOWS

EXISTING NOTE:
REAR DOOR FOR ENTRY
TO GARDEN-LEVEL APARTMENT
(TO BE CONSOLIDATED TO SINGLE
OCCUPANCY)

EXISTING NOTE:
DOUBLE BRICK SEGMENTAL ARCH AT REAR
WINDOWS, WHICH ARE 1-OVER-1 DOUBLEHUNG WINDOWS WITH ARCHED INFILL PANEL
AT HEADER
(TYPICAL AT ALL REAR WINDOWS)

METAL SECUIRTY BARS

CLPPED TO MASONRY

OPENING

(TYPICAL AT REAR GARDEN LEVEL WINDOWS)

EXISTING NOTE:
CHIPPING & DETERIORATION ON
STONE LINTELS
(TYPICAL AT ALL REAR WINDOWS)

WIRES & CONDUIT SPAN ACROSS
FACADES OF MULTIPLE BUILDINGS

EXISTING NOTE:
DEFUNCT ELECTRONIC CAMERA
ABOVE REAR DOOR

EXISTING NOTE:
DIFFERENTIATION IN BRICK COLOR
& TEXTURE INDICATES PATCHING
AND/OR REMOVAL OF PREVIOUSLY
EXISTING STRUCTURE IN THIS
LOCATION

EXISTING NOTE:
DETERIORATING METAL MESH INLAY
SECURITY SCREEN AT REAR ENTRY
DOOR

EXISTING NOTE:
DEFUNCT ELECTRICAL BOXES &
CONDUIT

- Clean and restore brick facade.
- Restore existing wood windows and paint, black.
- Cut back fire balconies at 2nd, 3rd & 4th Floor, to terminate just beyond the first window adjacent to 391 Marlborough Street.
- Install new steel-and-glass doors, to be sized to fit within the left and right extents of the existing window openings, and align with the windows above.

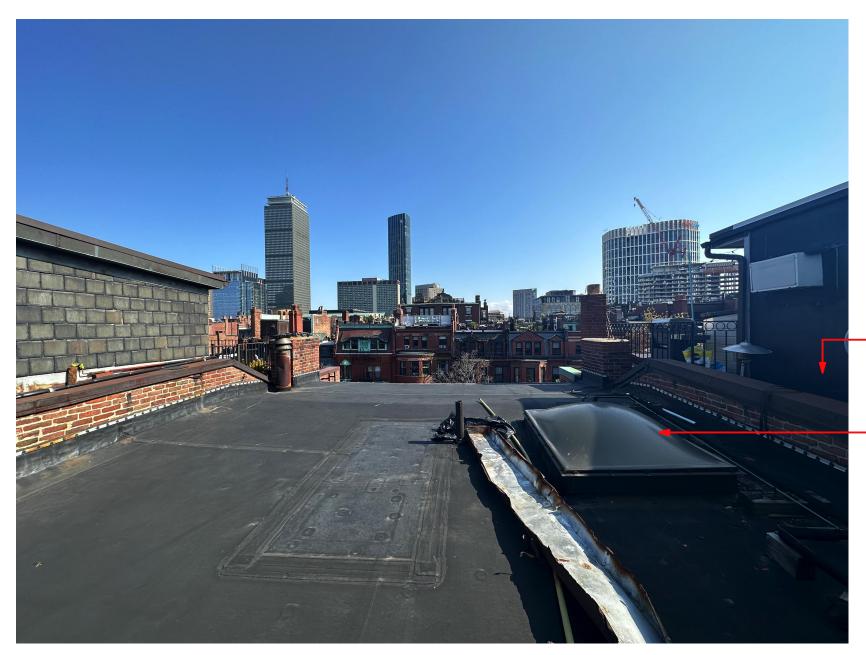
$\frac{\text{ROOF}}{\text{LOOKING SOUTH TOWARDS MARLBOROUGH STREET}}$

EXISTING NOTE:
DETERIORATION OF
METAL PARAPET CAP AT PARTY
WALL

- ACRYLIC DOME & CURB AT
LAYLIGHT (TO BE REMOVED)

- Replace all membrane roofing.
- Replace all party wall flashings with zinc-coated copper.
- Repair and restore brick chimneys along East Party Wall, including brick repair and new copper cap flashing.
- Install roof deck, including metal guardrail, between the party walls, and set back to the inside line of the chimney at the front of the building.

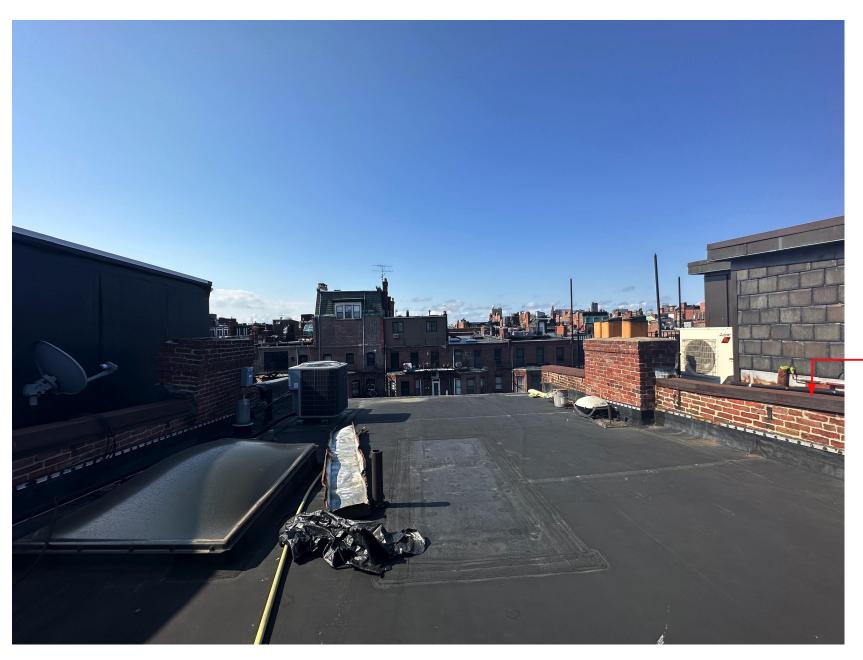
ROOF LOOKING NORTH TOWARDS PUBLIC ALLEY 414

EXISTING NOTE:
DETERIORATION OF
METAL PARAPET CAP AT PARTY

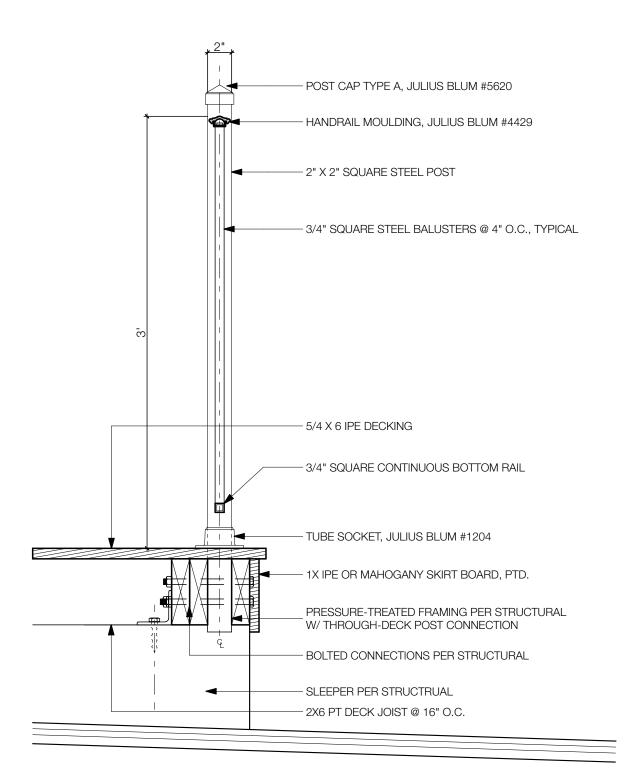
**ROOF DECK - RAILING DETAIL**

1 1/2" = 1'-0"

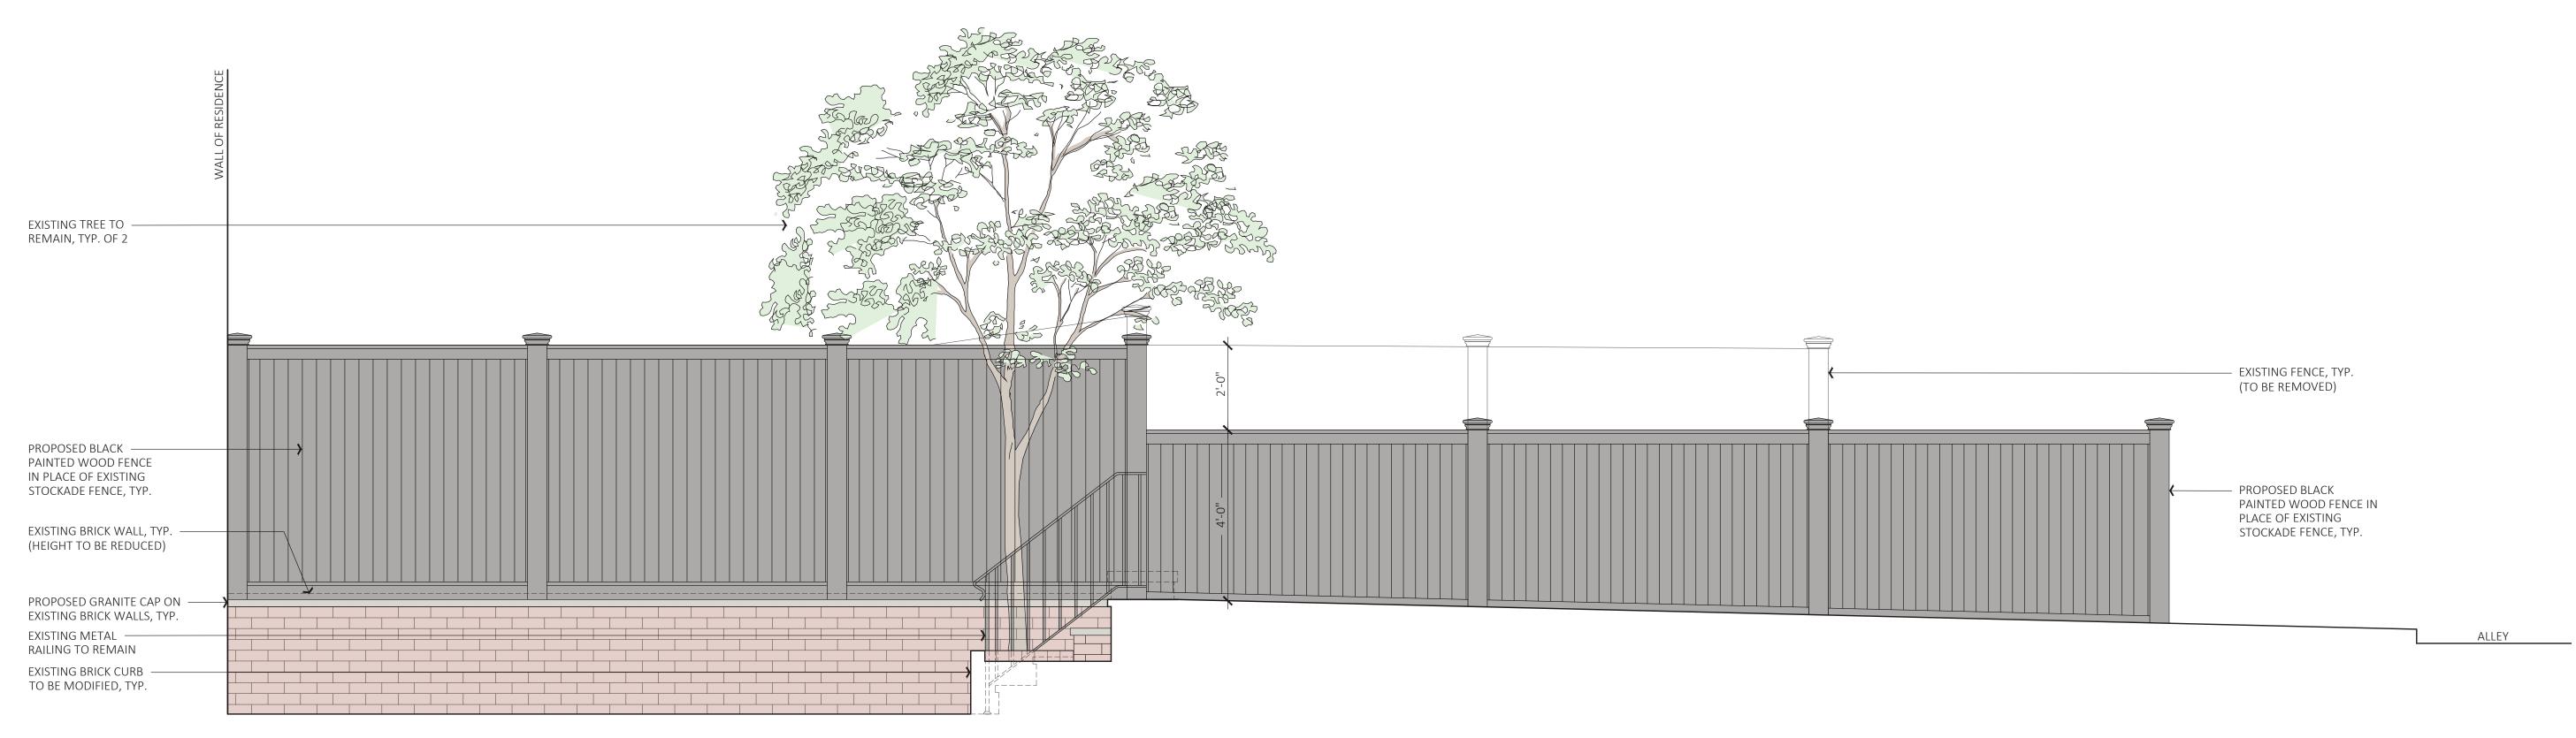
SECTION ELEVATION - LOOKING WEST THROUGH 389 MARLBOROUGH

SCALE: 1/2" = 1'-0"

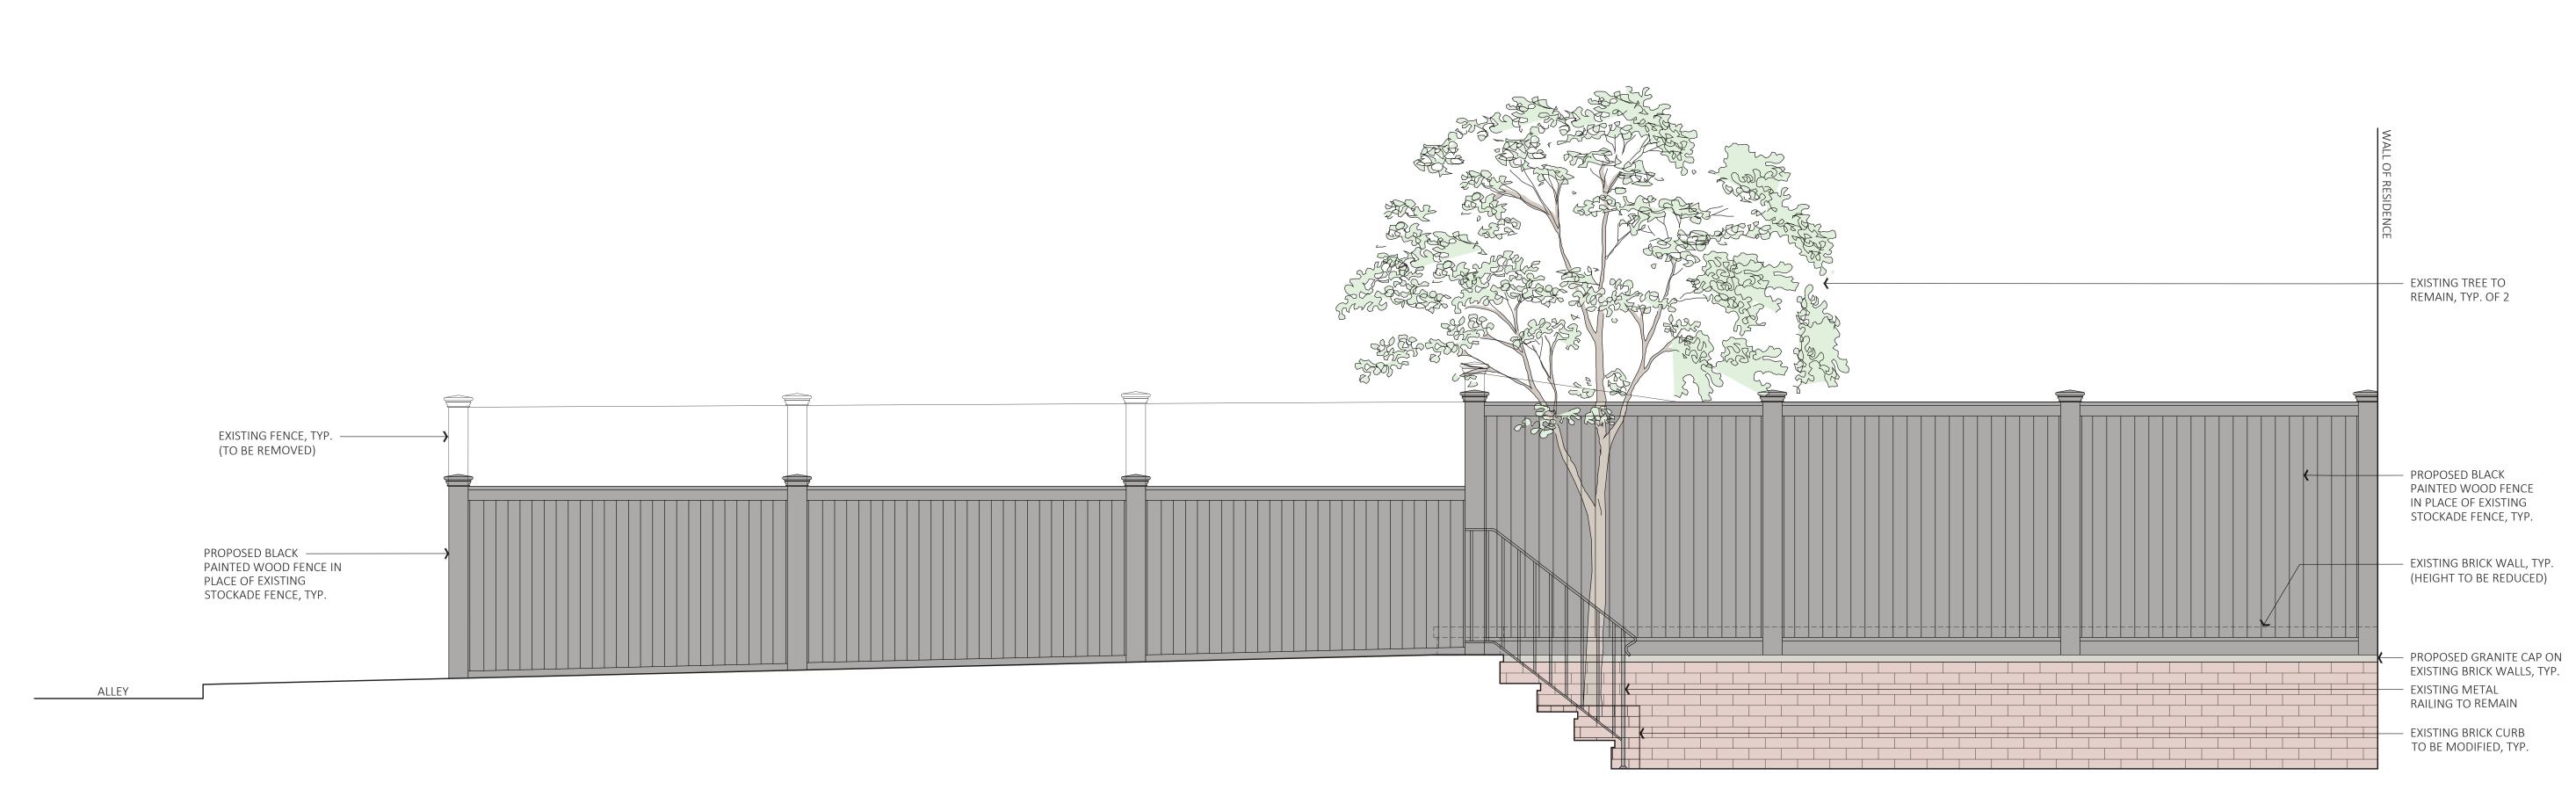
SECTION ELEVATION - LOOKING EAST THROUGH 389 MARLBOROUGH

SCALE: 1/2" = 1'-0
