18 RUTLAND SQUARE BOSTON, MA, 02118

PERMIT SET

A-203

We were asked by Holland Construction to do an assessment of the front windows at 18 Rutland Square.

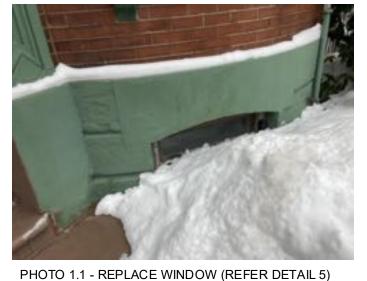
PHOTO 1.1 - REPLACE WINDOW (REFER DETAIL 5) RETAIN/ REPAIR LINTEL AND SILL, PAINT FINISHED (SEE NOTES) REMOVE WINDOW GRILLE

RETAIN/ REPAIR LINTEL AND SILL, PAINT FINISHED (SEE NOTES)

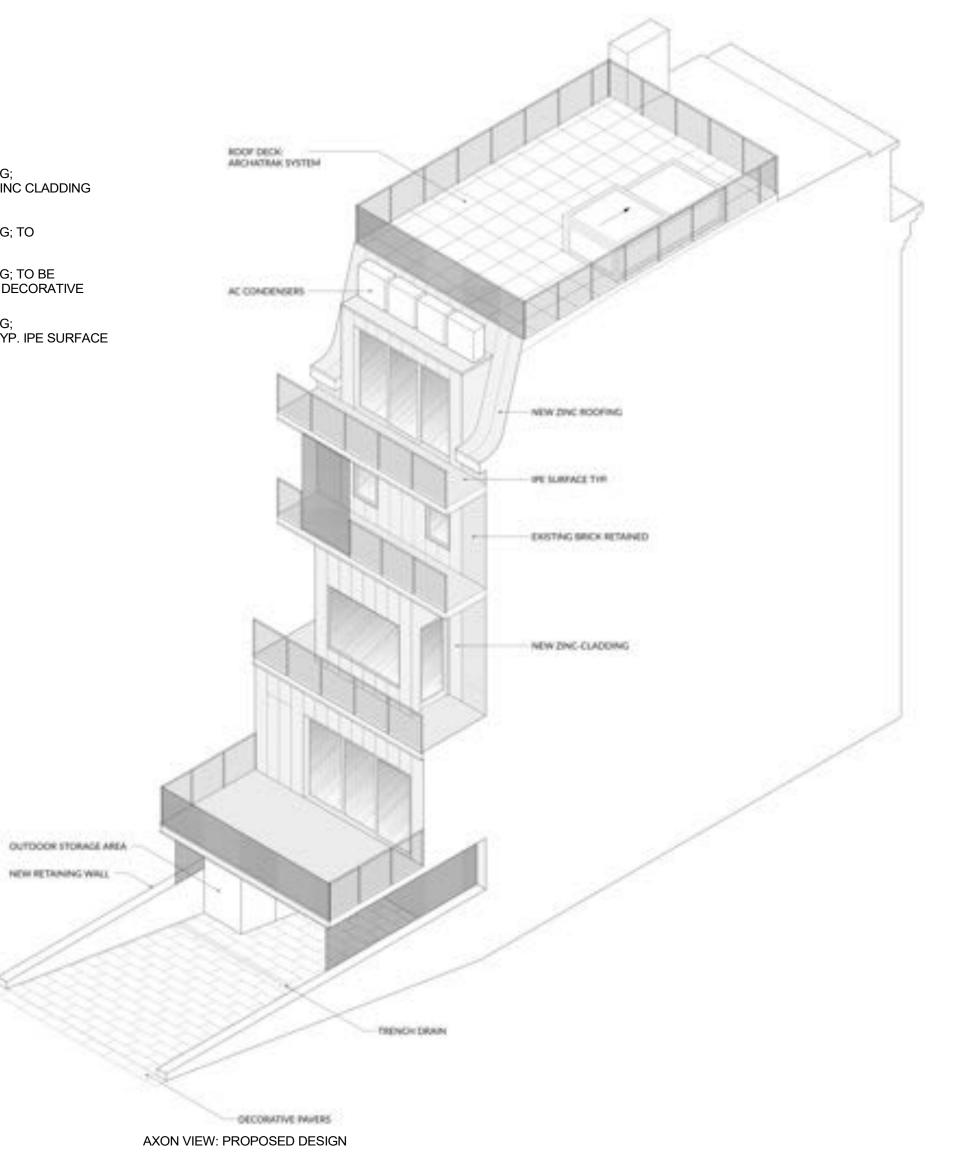
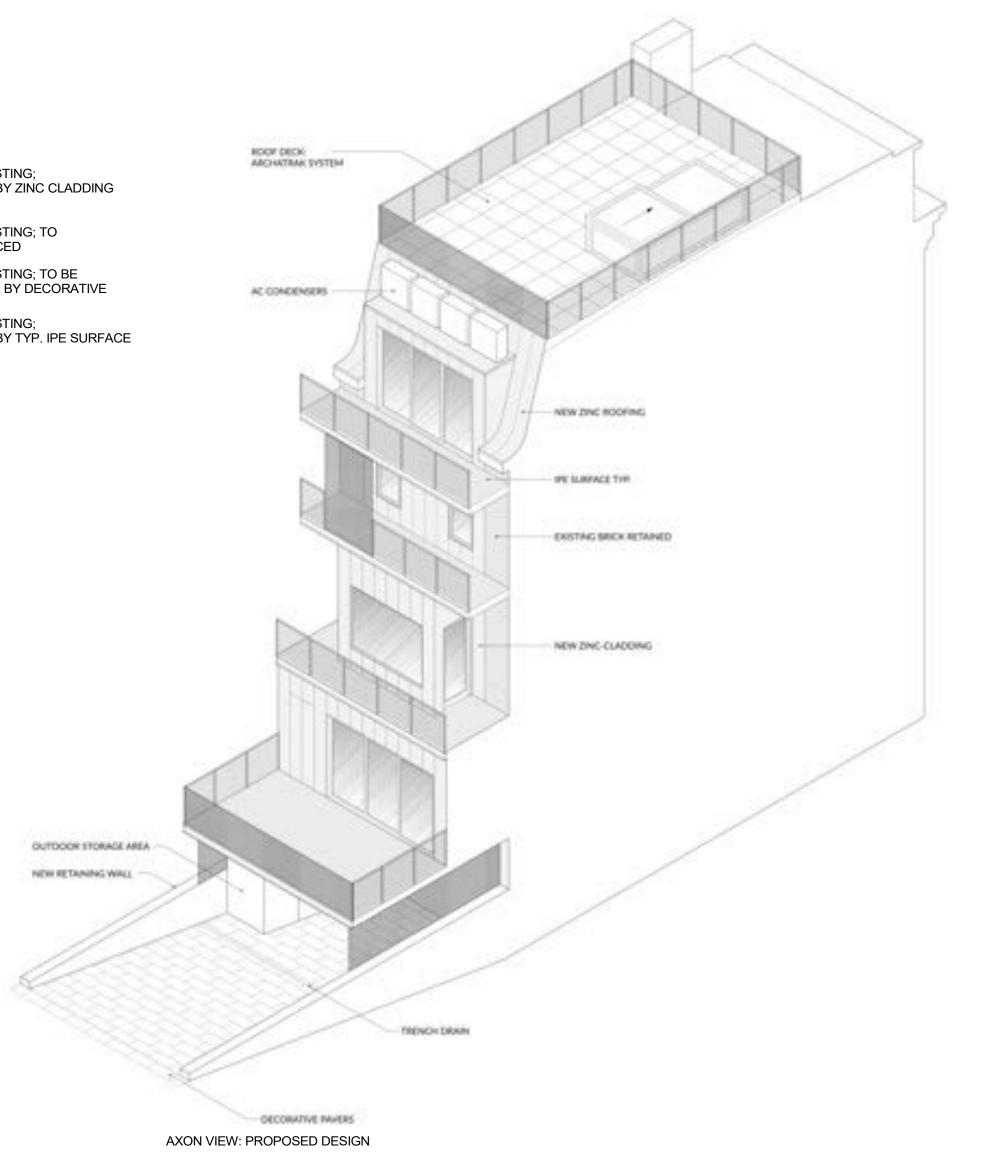
RETAIN DORMERS, MODIFY TO

REPLACE DAMAGED ROOF BY ZINC ROOFING

- REPLACE DAMAGED BRICK FACADE IN THE MIDDLE WITH ZINC

REPLACE CORRODED DOWN SPOUT BY NEW

RETAIN BRICK, REPOINT AND

REPLACE CORRODED FLASHING BY

RETAIN ORIGINAL BRICK ON THE

SIDES, REPOINT AND REPAINT. REFER AXON.

- DEMO EXISTING; REPLACE BY ZINC CLADDING
- DEMO EXISTING; TO BE REPLACED DEMO EXISTING; TO BE REPLACED BY DECORATIVE
- SCREEN DEMO EXISTING; REPLACE BY TYP. IPE SURFACE

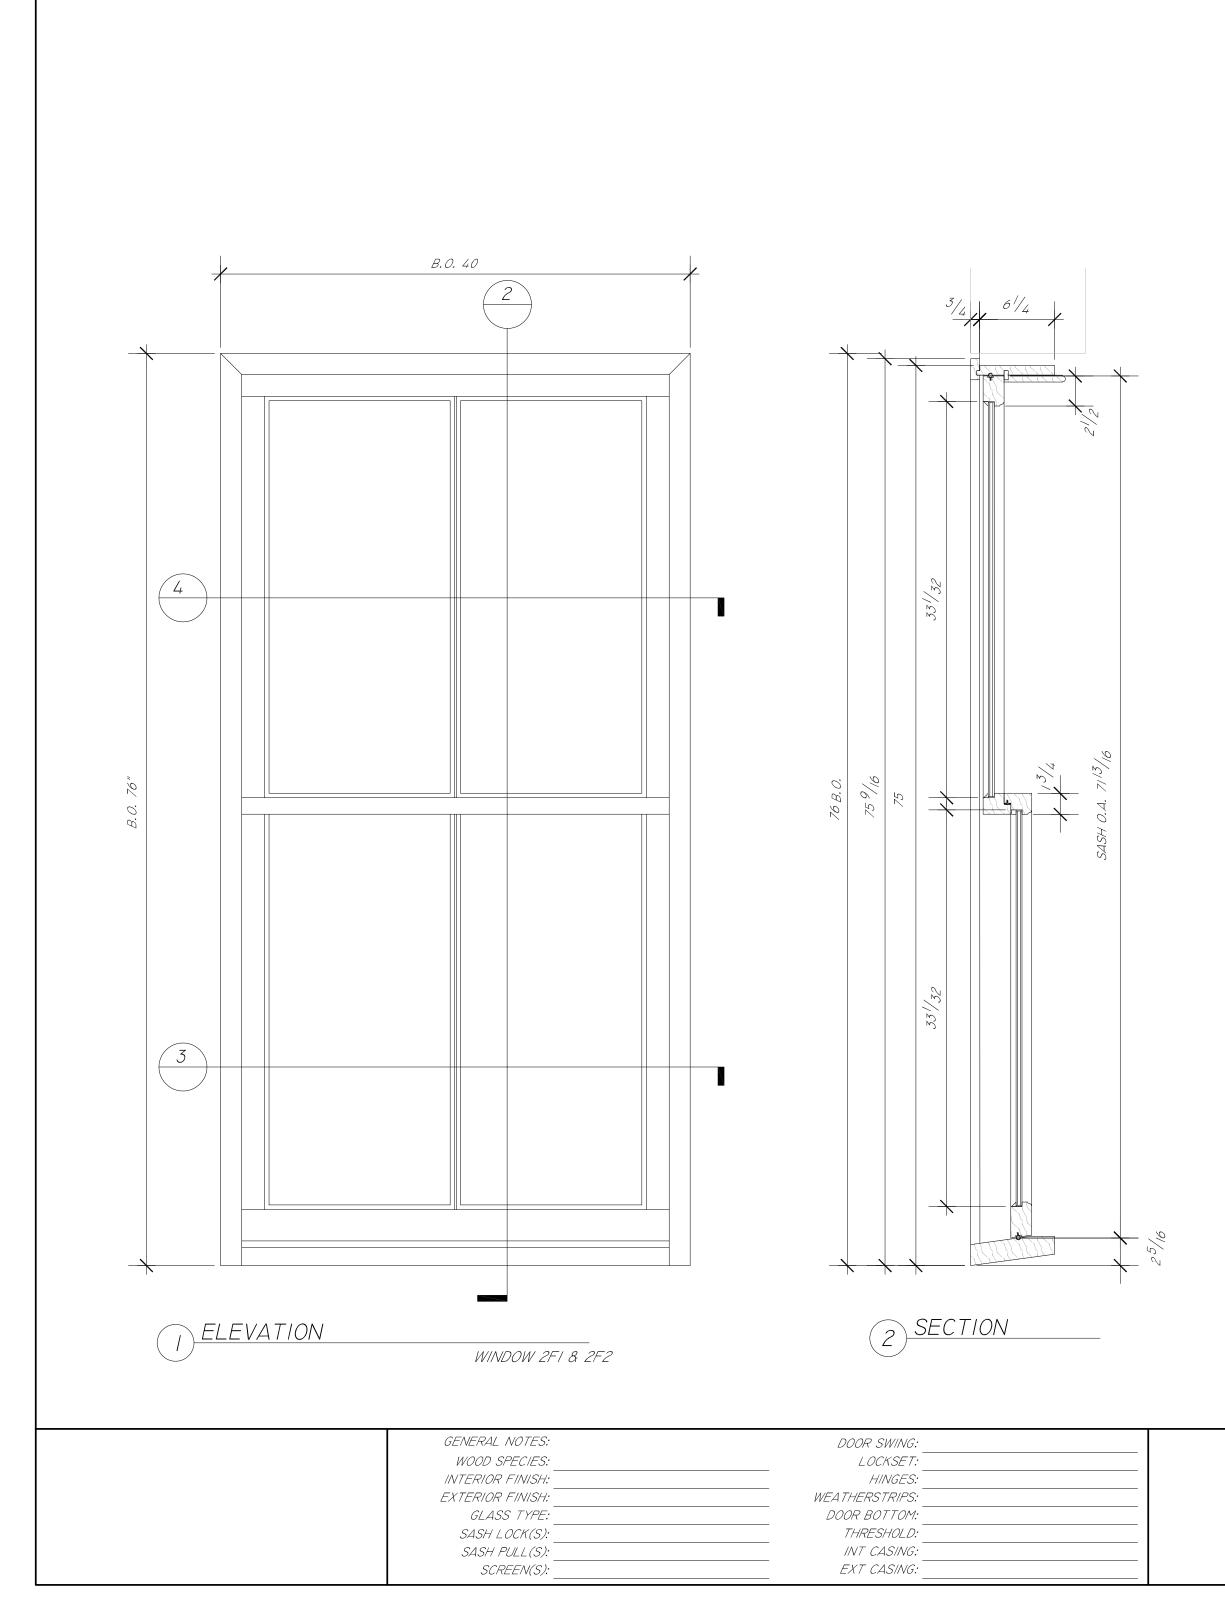
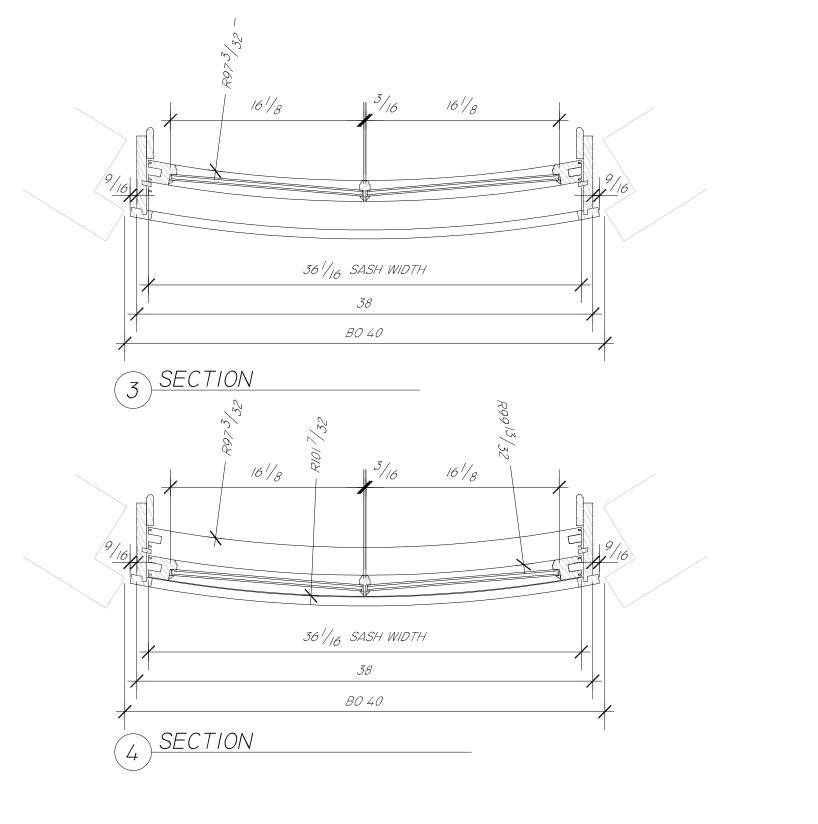
JOB NUMBER: 23001		PROJECT NAME: I8 RUTLAND SQ., BOSTON, MA
	PM: GREGG MARTIN	DRAFTER: KTD	TITLE: WINDOW ELEVATION AND SECTIONS
	ENGINEER: DWG DATE: <u>03/28/2023</u> REV I:	REV 2: REV 3: REV 4:	DRAWING NUMBER: BOWED WINDOW PAGE 1 OF 3

Overall, these windows are in poor condition and should be replaced. The sashes are not holding together well and can hardly be opened because of the caulk etc. that has been put on them in a hope of not letting the cold. The sills are rotting and the frames have been damaged along the way as well. The sashes no longer fit into the frame well enough to be weatherstipped.
