Report of the Boston Landmarks Commission
on the Potential Designation of
THE PROCTOR BUILDING

Landmark under Chapter 772 of the Acts of 1975, as Amended

July 1, 1983

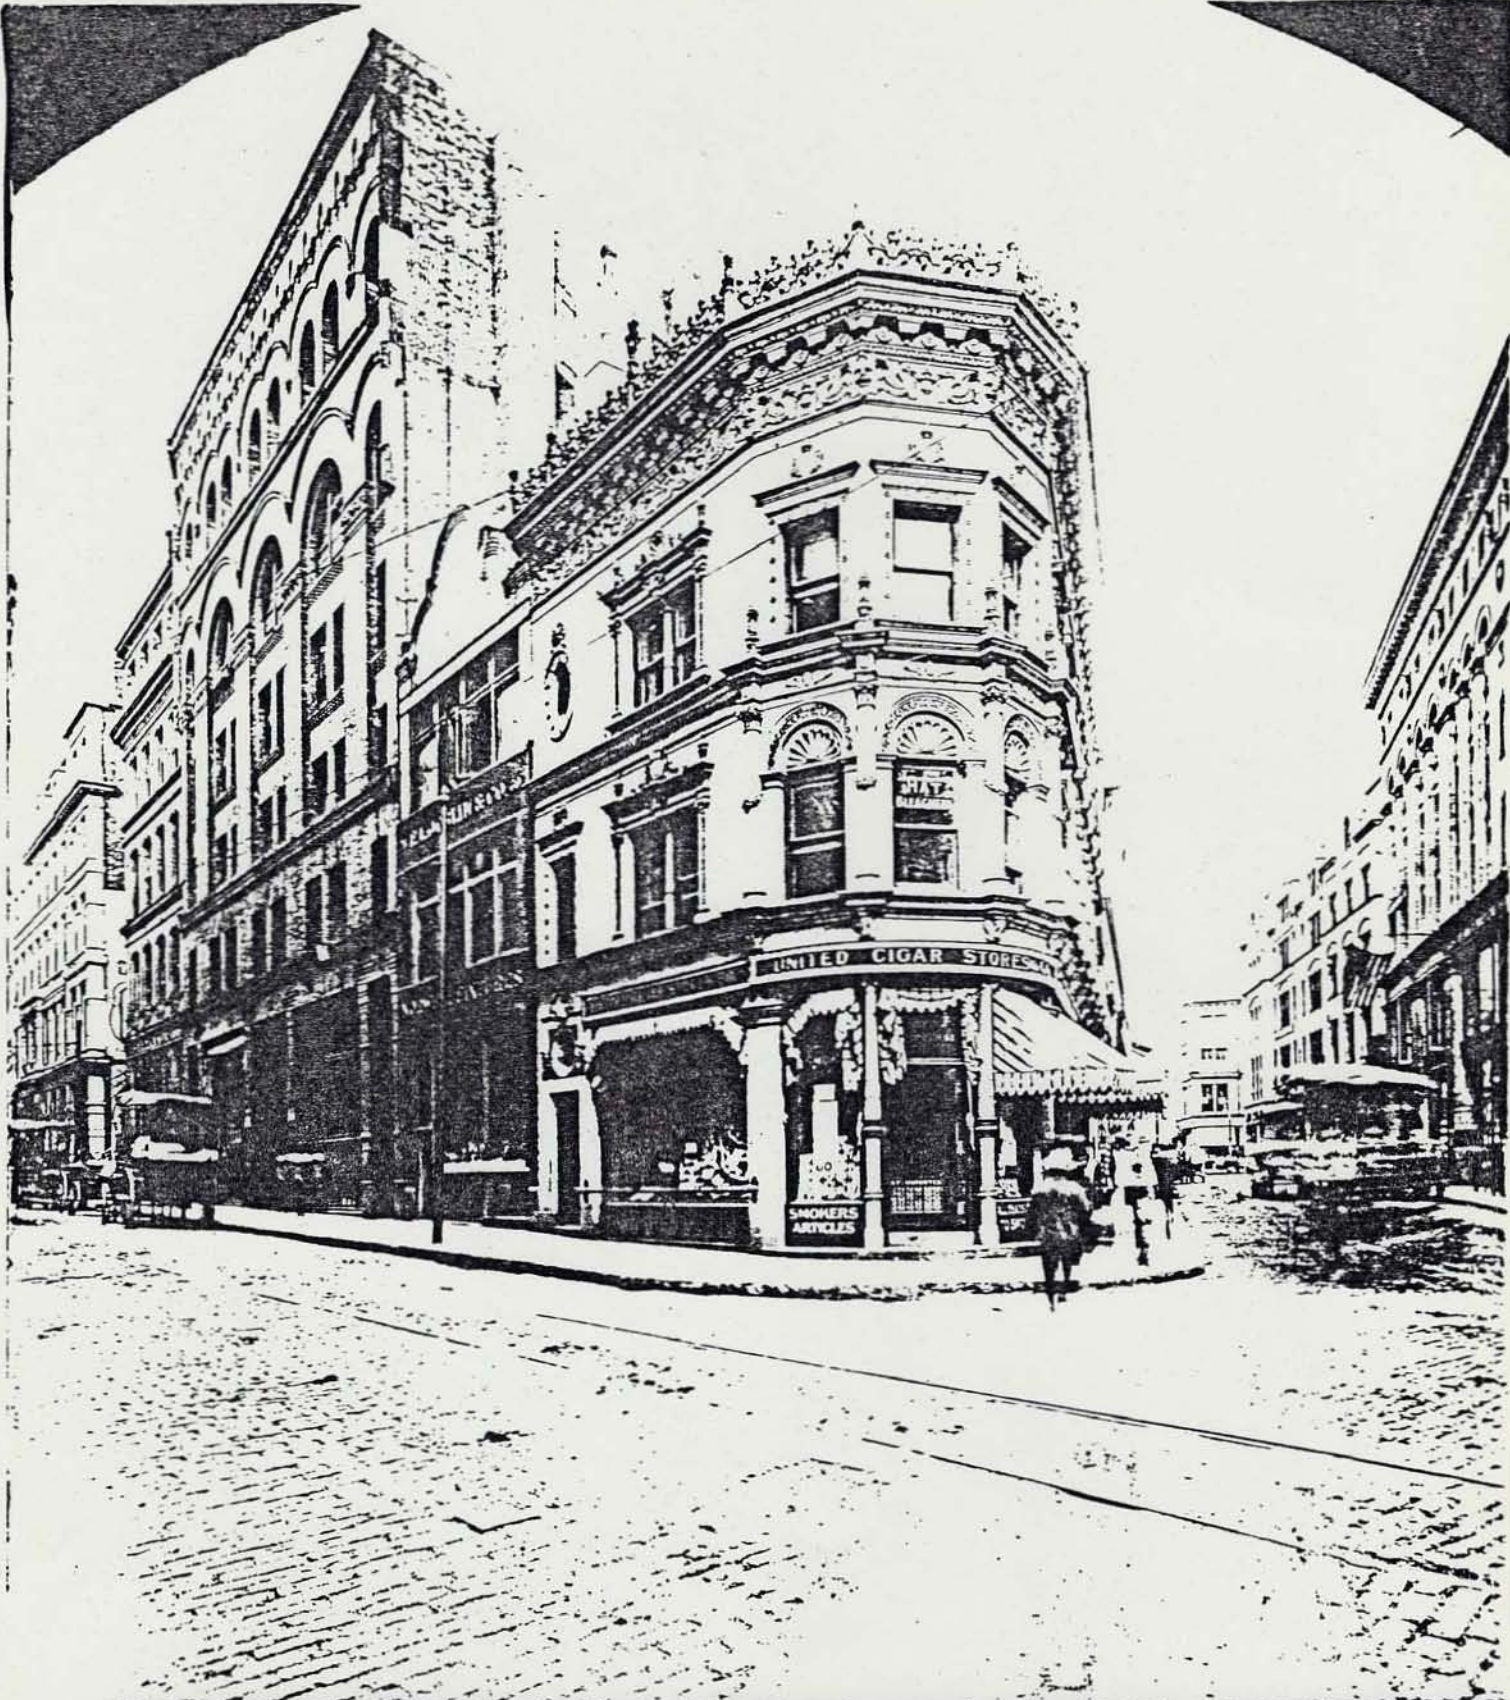
34

E. side of Kingston N. side of Bedford Sts.

July 28. 1903
